2011

Miner- Cutter head

Gearbox teardown & Vibration

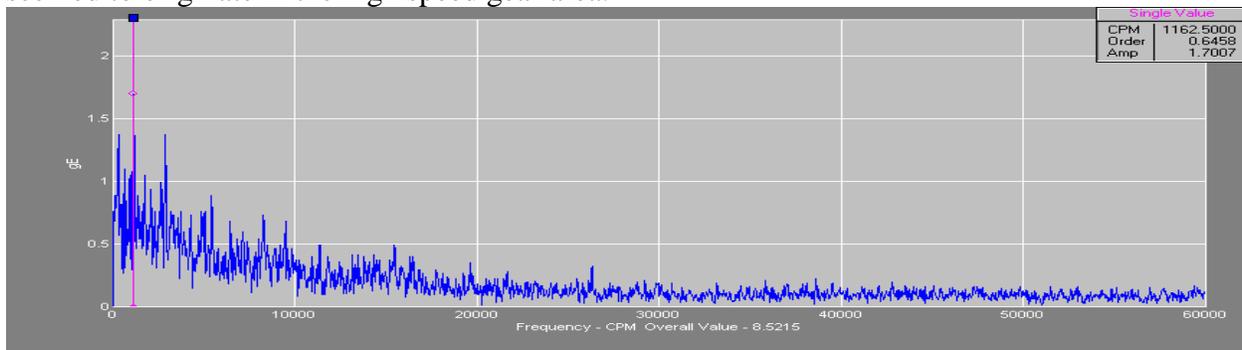
Gear A, and gear B area reading (gE)

The spectrum below was taken on the left side cutter head gearbox (A gear, and B gear area). The spectrum shows raised floor. Highest peak in the spectrum is 1162 CPM, which is the running speed of the reach gears. The left cutter head has also had a loud audible noise which seemed to originate in the high speed gear area.

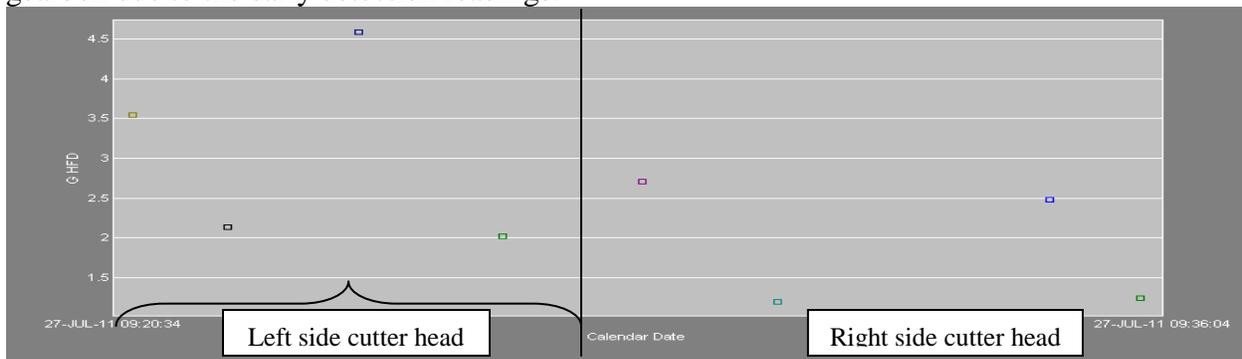
Seen below are the HFD readings taken on the left, and the right side cutter head. As we can see the left side shows more metal to metal contact/lack of lubrication than the right side. The highest high frequency reading is on the reach gear area (4.5 G's). Replace the left side gearbox due to the early detection readings.

Vibration readings were not trended on the unit, and could not be monitored for the increase over time, thus we have compared the vibration readings taken on the left, and the right side cutter heads. Early detection readings (enveloped acceleration) have indicated metal to metal contact /lack of lubrication on the left side cutter head unit, high speed gear area.

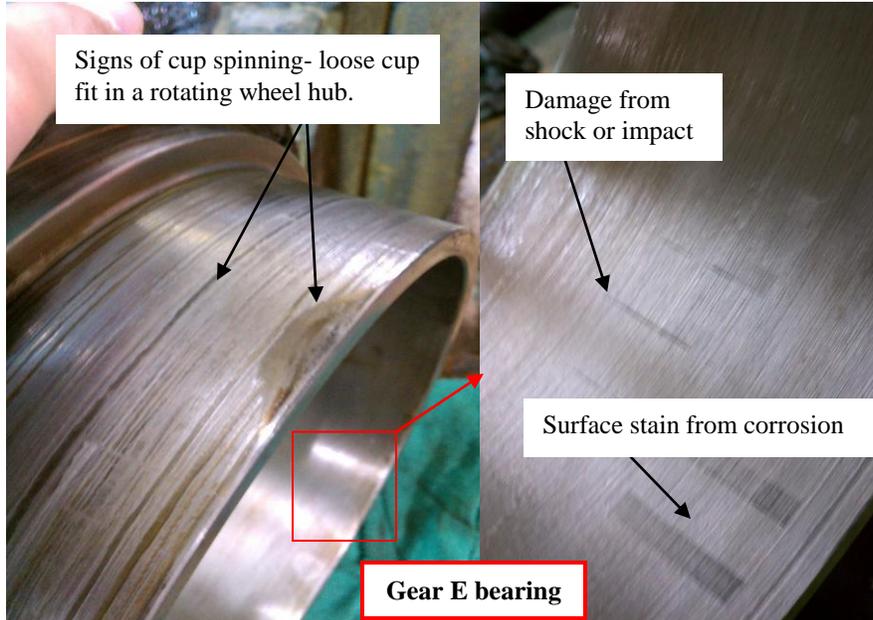
Finding #1- Low speed gears

The E gear bearing shows impact damage, and surface staining on the outer race. Inner race shows signs of cup spinning- loose cup fit in a rotating wheel hub. Metal to metal contact has started to occur.

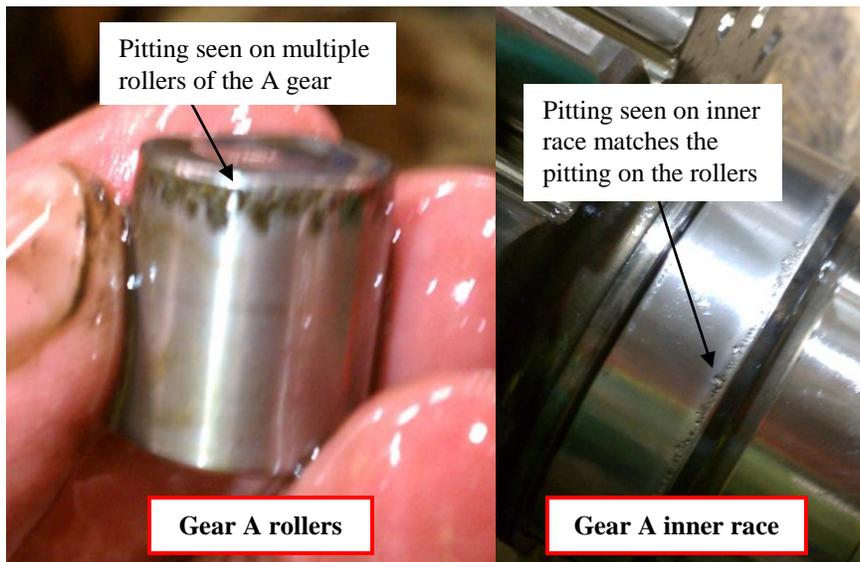
Finding #2- High speed gears

The A gear bearing show pitting on the inner race, which can also be seen on the rollers. Rollers also seemed to be loose in the cage. When the shaft was pulled out of the bearing, the rollers fell out of the cage, which should not happen in this type of bearing. The slight pitting was also present on the D gear bearing.

The tear down of the left side cutter head gearbox determined the unit was in the early stage of failure. The visual inspection has found pitting all around the inner race and on the rollers of the gear A bearing. Rollers also seemed to be loose in the cage. The slight pitting was found on the D gear bearing. The E gear bearing showed impact damage, slight surface staining, and signs of loose cup fit in the rotating wheel hub. Our concern lied mostly around the A gear bearing, due to it being the high-speed bearing, and the degradation would happen more rapidly.
