Planetary Set-Up

Ring Gear Cocked in Housing

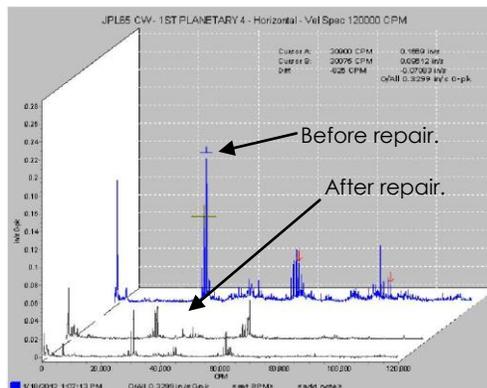
Upon disassembly of the gearbox, it was found that the ring gear was cocked in the housing and off a total of 0.008 in. This flaw had resulted in elevated gear mesh frequencies with ring gear sidebands and the presence of a ring gear fundamental frequency in the gathered vibration spectrums.

From back to front, the waterfall above shows the initial test stand run with the ring gear issue, the test stand run after the issue had been corrected, and the corrected gearbox run as a powertrain with the service motor installed.

It can be seen that the ring gear fundamental, the gearmesh harmonics, and the ring gear sidebands all decreased significantly after the issue was corrected in this large gearbox.

After fixing the ring gear issue, the gearbox was reassembled, and further vibration testing confirmed that the problem had indeed been corrected.

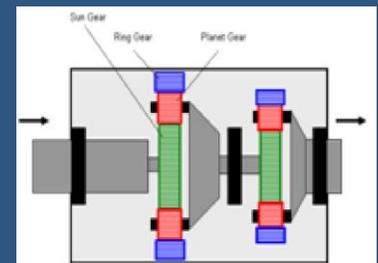
Gearbox set-up with two planetaries.
