Airborne Ultrasound Case #1

Cracked insulator on high voltage application.

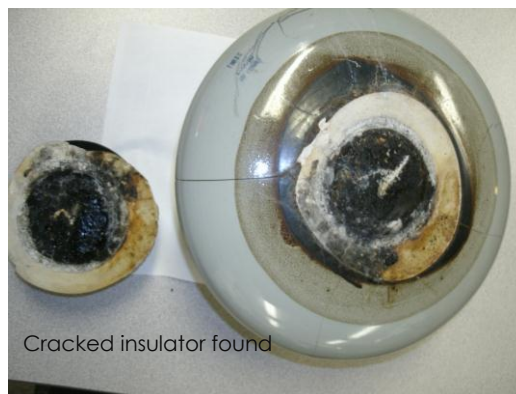
Insulator break down can occur from lightning strikes or excessive tension on electrical wiring. After these events occur, the insulator can crack causing high amounts of corona, tracking or even arcing. This leads to insulator failure causing damage to other components and later on unscheduled down time.

For example a cracked insulator found to have numerous cracks present did not show up on infrared camera equipment however using airborne

ultrasound test equipment, the technician heard a high amount of corona/ tracking. Further inspection of the framework revealed burning and other failing areas of the wooden substation structure. Immediate notifications were made and personnel mobilized for repair. This repair prevented further damage to any other components or unplanned downtime that might have occurred.

Cracked insulator found

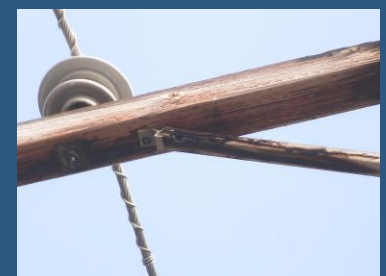
Electricity trying to go to ground burns cross arm .
