Vibration analysis Long wall ranging arm

High speed gear bearing defect

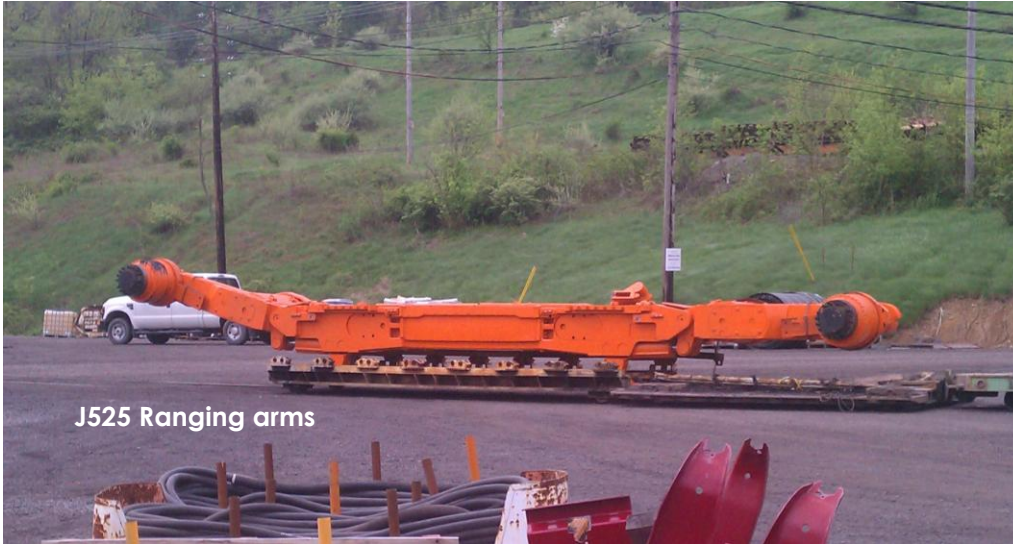
Long wall shearer operators have noticed a high pitch sound coming from the head ranging arm. Vibration analysis on the unit was then completed in order to determine what mechanical component was making the noise, and the severity of the situation.

The vibration spectrums collected showed the outer race bearing defect on the high speed gear A, and gear B area is present. The recommendation to the mine was made to replace both gear A, and gear B bearings as soon as possible. The work was scheduled, and completed on Sunday without any production loss.

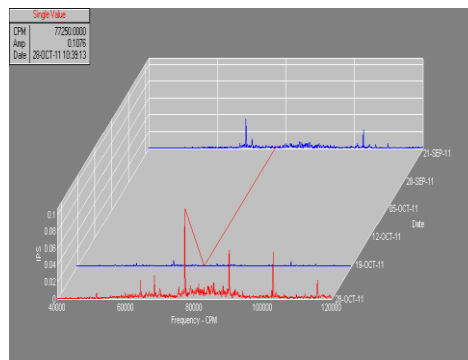
Waterfall showing the change since the last inspection

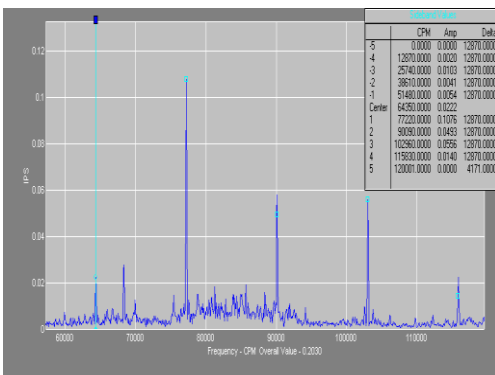
Spectrum showing the outer race bearing defect

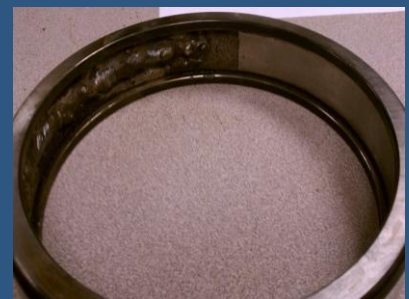
After visually inspecting the replaced bearings, it was determined that motor side gear A bearing had damaged outer race. The damage most likely occurred in the load zone considering only half of the outer race showed spalling.

Outer race bearing defect of gear A bearing found through vibration analysis
