Trolley Wire Insulator

Why inspect mines with Infrared?

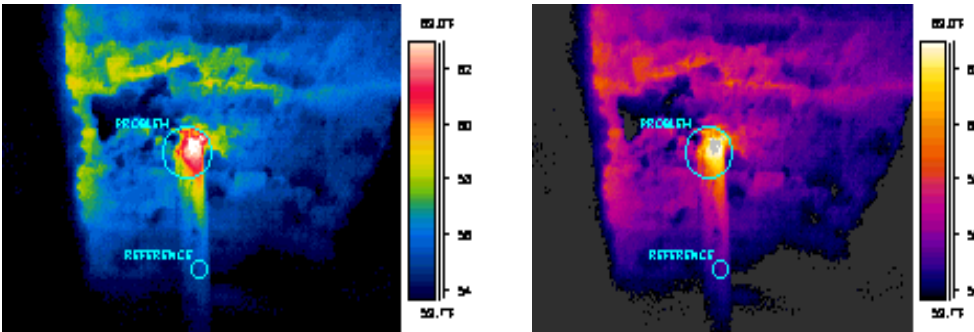
The inspection of Coal Mine Underground Trolley Systems with Thermography is very important to mine safety. Loose or improper connections of the DC trolley system can cause electrical outages, fires, or even roof falls. The example below shows a trolley insulator that has shorted causing current leakage through the support bolt into the roof. The trolley wire is the positive side of the power supply that is insulated from the roof by using insulators. The rail is the negative side that equipment operates on, similar to a train.

The two pictures above show the trolley hanger where it goes into the roof. You can see the temperature change and heat at the point where the hanger metal rod goes into the roof rock structure. There was an ambient temperature of 46 degrees F in the area, and the roof temperature changing from 63 to 58 degrees F. With the 63 degrees F located where the hanger entered the roof. You can also see the migrating temperature change in the roof. The picture on the left is an IR picture taken in a color palette of Rain 900, and the picture on the right has a color palette of Iron.

- Using Infrared a potential safety hazard was prevented.
- Infrared can be used to check both DC systems like the trolley and AC systems like distribution.
- Infrared can be used to inspect other things such as belt starters, power centers, equipment plugs, and breakers.

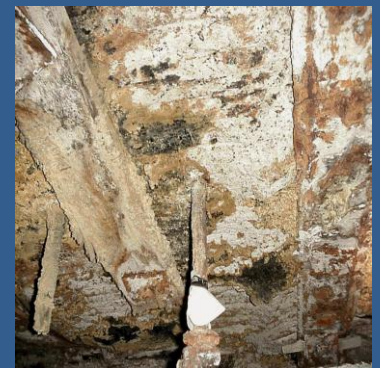
The insulator hanger marked with a paper cup so the insulator can be immediately replaced
