Air Pulsation

Ventilation Fans

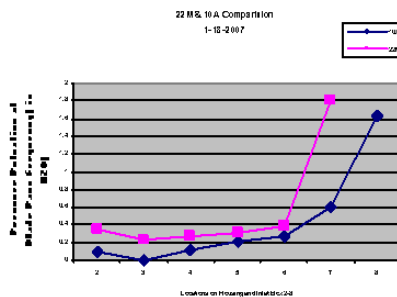
The unit can be monitored using air pulsation analysis. Air pulsation analysis includes the placement of the sensor in both upstream and downstream areas of the fan impellers over small holes predrilled by the fan manufacturer. Air pulsation analysis is measured around a blade pass frequency in which the results of each analysis are then charted to trend static pressure variations at each point as seen to the right.

What we use in our comparison chart is another fan that is similar in construction with the overall readings. If another fan is not available of the same make-up, we would use a waterfall spectrum that can be generated so we can give the customer a comparison to trend over time the change.

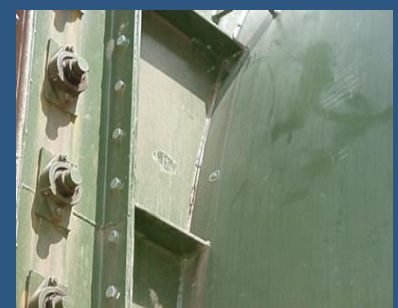
This picture shows the cracks found in the fan housing

If a problem was detected on the fan housing area we would determine at what location was the highest overall reading recorded. Usually if the fan pulsation has indications of high readings on an inlet point area, it is usually an induced draft or forced draft (uneven airflow). The corrective action would be taken to determine where the secondary flow exists and placing a vortex breaker to destroy the secondary airflow.
