2011

Miner- Cutter head

Gearbox teardown & Vibration

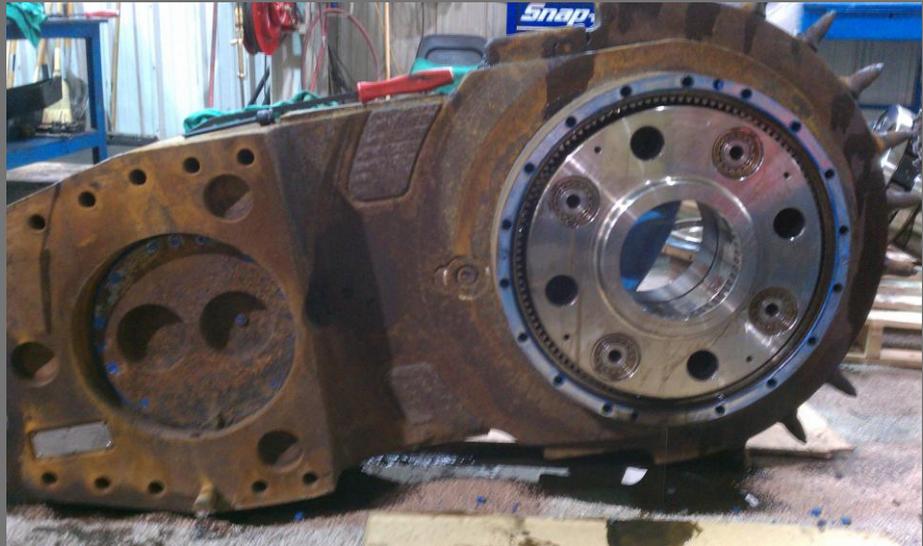
Cutter head gearbox was replaced due to the loud audible noise occurring in the high speed gear area, and the vibration analysis results. Wear on the gears/bearings was inspected at the Joy rebuild facility, and compared with the vibration data.
