Planetary Set-Up

Ring Gear Cocked in Housing

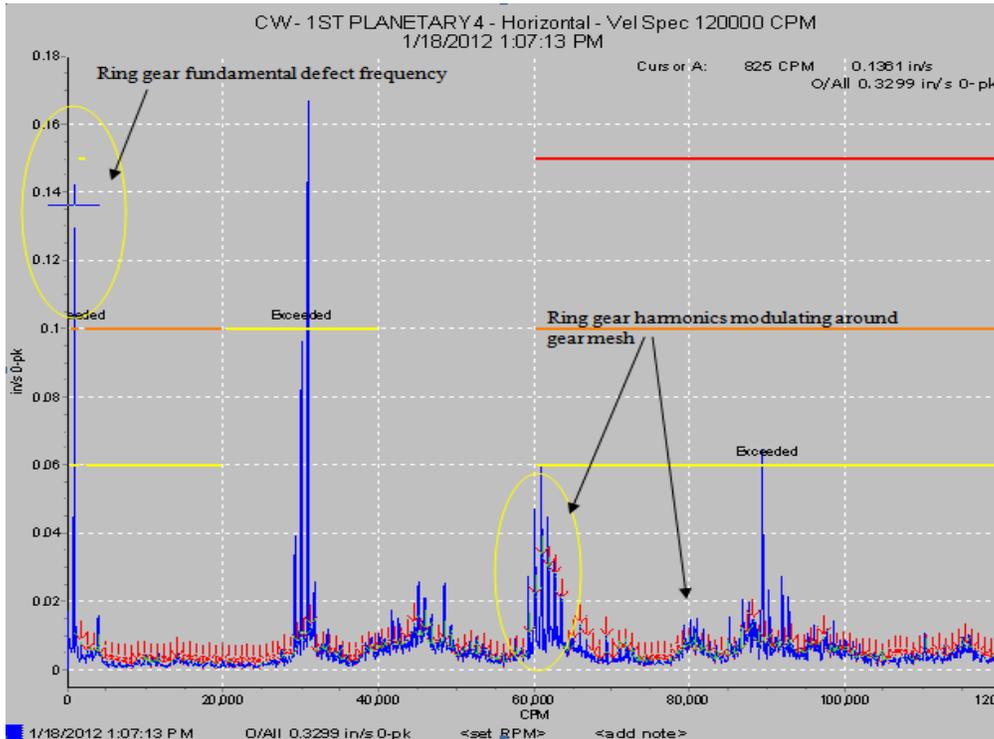
This value was again shown with a gearbox. Through the use of vibration inspection data, the presence of a ring gear flaw was determined prior to the gearbox being attached to a service motor for delivery to the customer.

Upon disassembly of the gearbox, it was found that the ring gear was cocked in the housing and off a total of 0.008 in. This flaw had resulted in elevated gear mesh frequencies with ring gear sidebands and the presence of a ring gear fundamental frequency in the gathered vibration spectrums.

After fixing the ring gear issue, the gearbox was reassembled, and further vibration testing confirmed that the problem had indeed been corrected.
